# Smart Cushion 2 Year In-Service Summary Report

## Smart Cushions In-Service

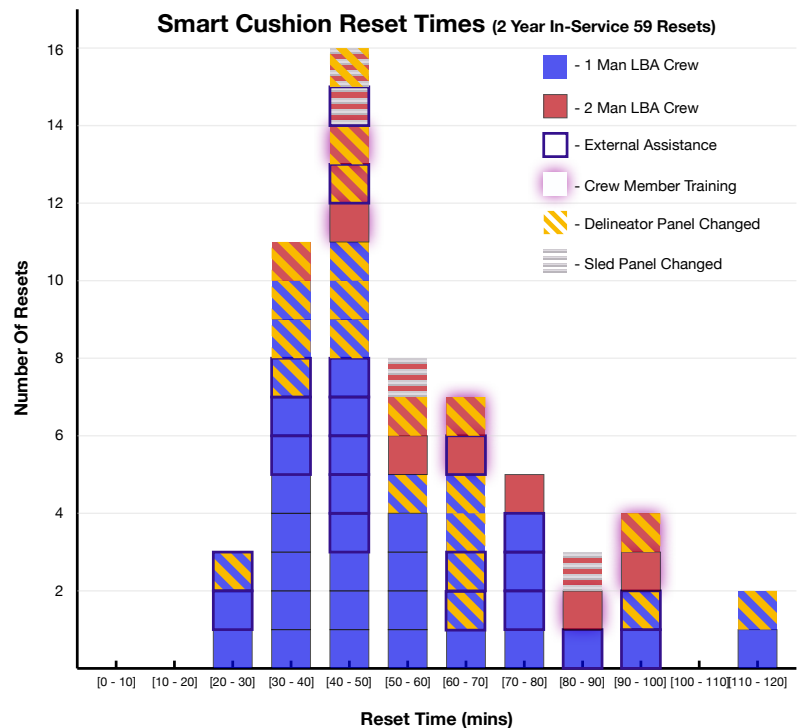
- LBA crew performed all 59 required resets in this period
- All resets were due to frontal impacts
- There was evidence of side impacts (eg. paint transfer, tyre marks etc.) however no damage was reported for repair
- Reset times were recorded from the moment inspection of the Smart Cushion started, to the time that the reset was completed and tools were packed away ready to leave site
- The average reset time was 55 minutes, and the median time was 49 minutes
- 25 resets were performed by a 1 man crew
- 18 resets were performed by a 1 man crew with assistance from a 3rd party vehicle for the pullout of the frame and mobile sheaves
- 2 or more men were used when one was being trained, a sled panel was being replaced or other work was conducted on the same night e.g. relocate a different Smart Cushion

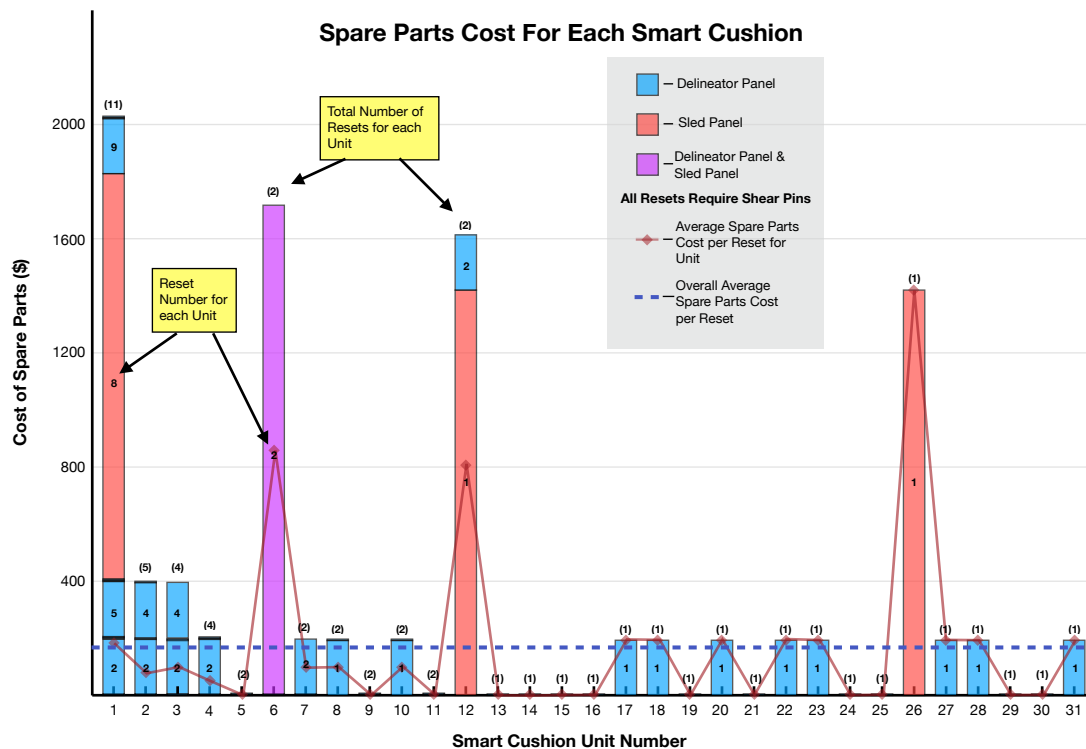
- 3 main types of components were replaced over the 59 resets
- Shear Pins (2 x \$2 = \$4) required for every reset
- Delineator Panel (\$190) required for 21 resets
- Sled Panel (\$1416) required for 4 resets
- The total cost of replacement parts over the 59 resets was \$9,994
- The average cost for each reset was \$169
